Upper Truckee River

Meiss Allotment Aquatic Habitat Trend Analysis

UDSA FOREST SERVICE LAKE TAHOE BASIN MANAGEMENT UNIT

August 2015

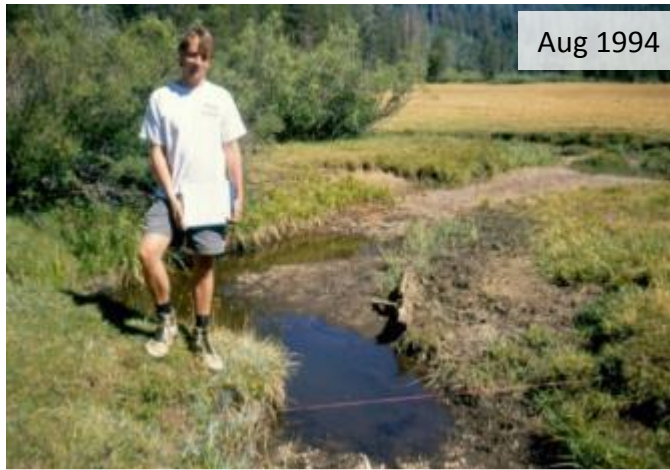
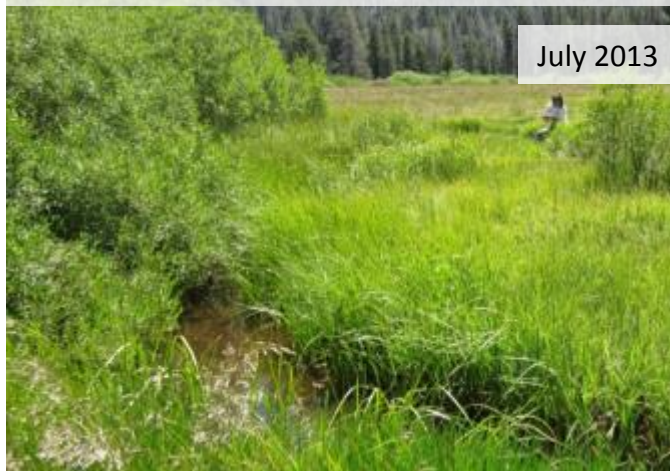
Aug 1994

Time series photos of aquatic habitat condition in Big Meadow

July 2013

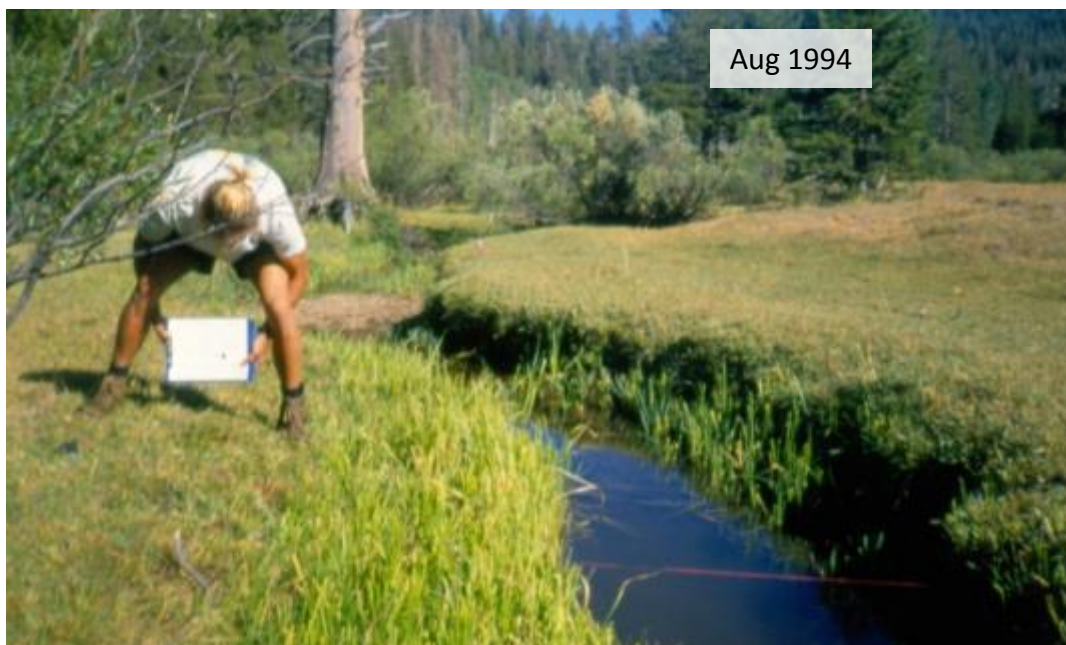
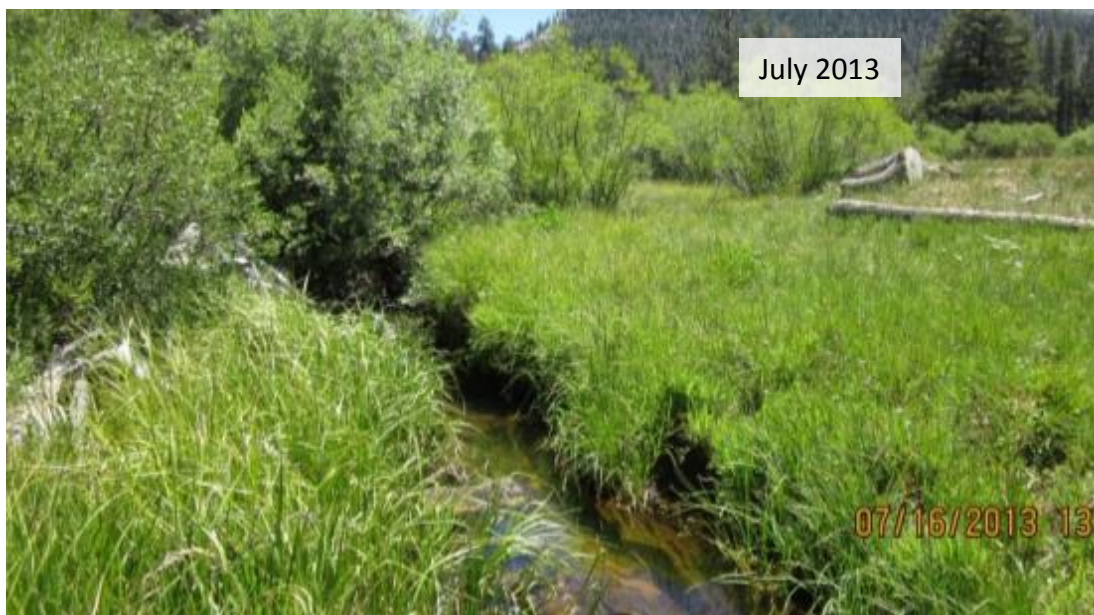
FIGURE 9 – Photos of the change in vegetative cover that caused stream shade to increase in Big Meadow.

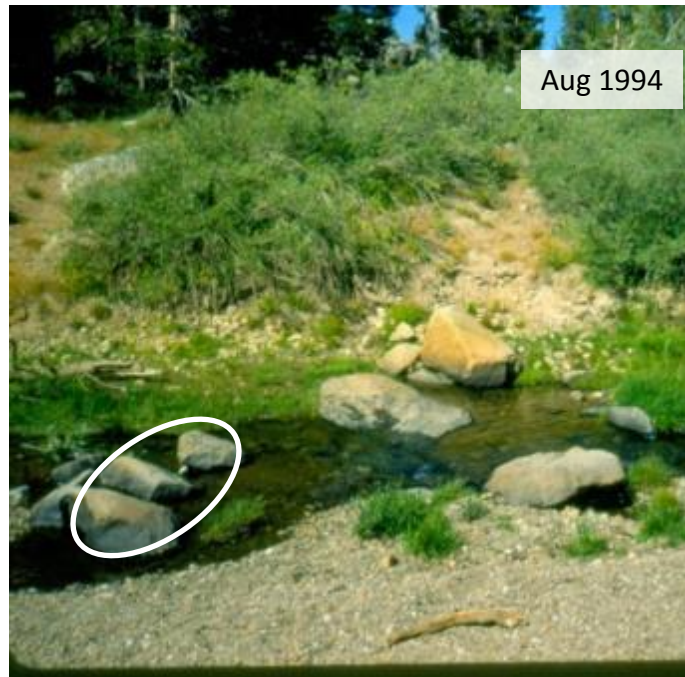
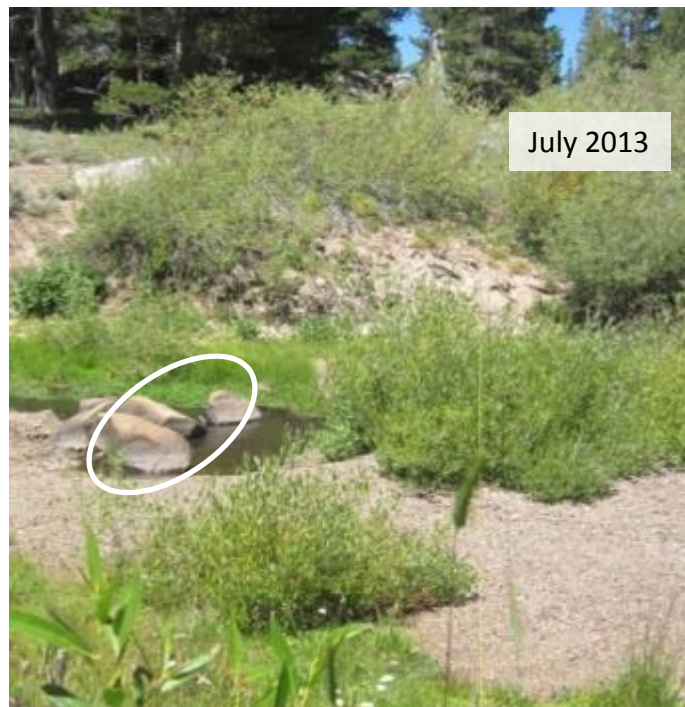
FIGURE 10 – Vegetation changes leading to improved stream bank stability in on the Upper Truckee in Meiss Meadows. Boulders are circled as datum for comparison.

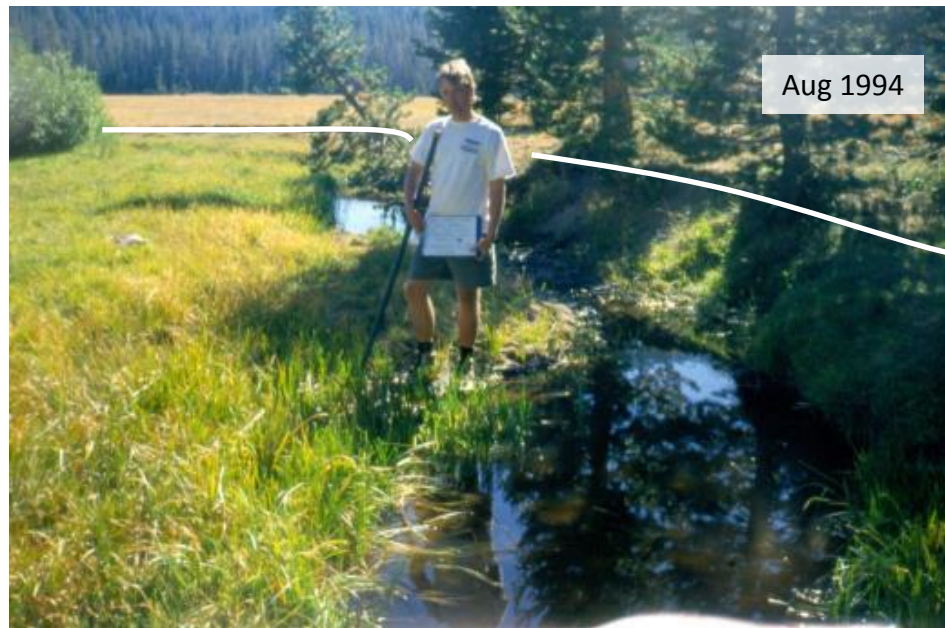
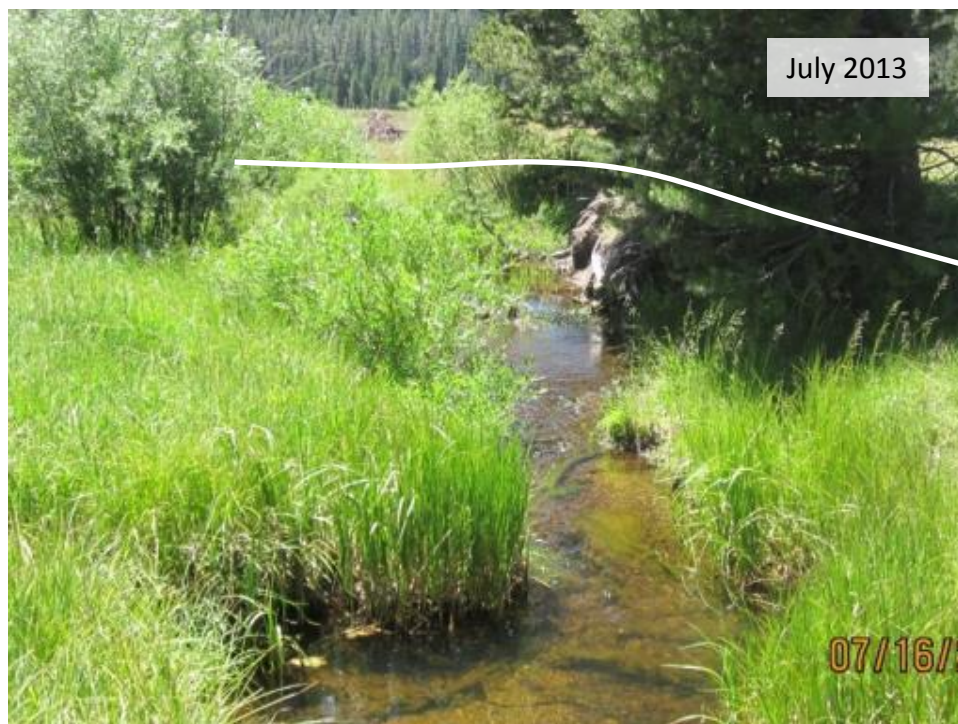
Figure 11 - Photo of channel and confining bank conditions (top of confining bank shown with white line) pre and post grazing. Surrogate data indicates a slight improvement in the Big Meadow entrenchment ratio.

The entrenchment numbers at Big Meadow are inconsistent and there is not enough data to demonstrate a trend at any cross section numerically; however, nearly all entrenchment values on permanent cross sections collected over time exceeded a value of 2.2, at which the channel is considered minimally entrenched (Rosgen, 1996), a condition where flood flows spread out enough laterally to minimize channel energy and keep erosion at a natural level.

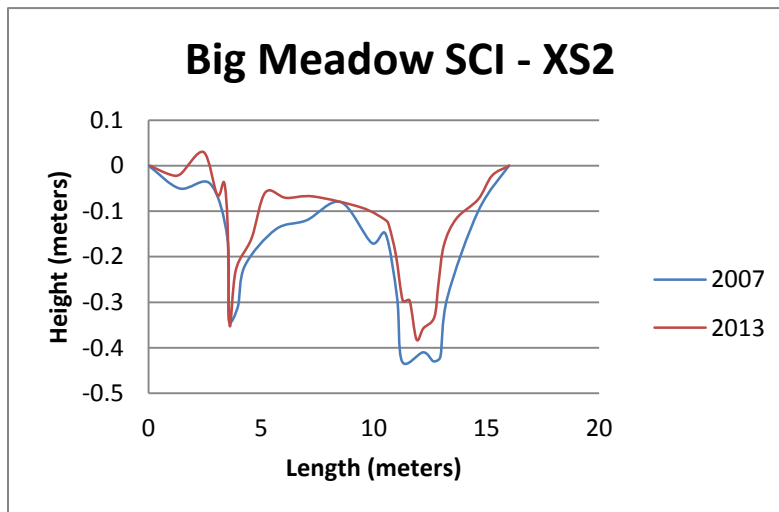
Permanent Cross Sections and Cross Section Shape Data

Big Meadow SCI Bankfull W/D Ratio				
Year	XSEC1	XSEC2	XSEC3	Median W-D ratio
1995	16.72	NR	8.08	NC
2001	9.05	NR	9.06	NC
2007	8.69	20.65	4.37	8.69
2013	8.5	18	4.2	8.5
NC = not recorded / NC = not calculated

Big Meadow SCI Entrenchment Ratios										
Entrenchment Ratio - Permanent XS				Median Entrenchment ratio	Entrenchment ratio - random cross sections					Median Entrenchment ratio
Year	XSEC1	XSEC2	XSEC3		Random 1	Random 2	Random 3	Random 4	Random 5	
1995	16	NR	8	NC	NR	NR	NR	NR	NR	NR
2001	3+	NR	3+	NC	3	3	3	4.1	6.7	3
2007	32	2	14	14	NR	NR	NR	NR	NR	NR
2013	NR	NR	NR	NR	NR	NR	NR	NR	NR	NR
NR = not recorded / NC = not calculated

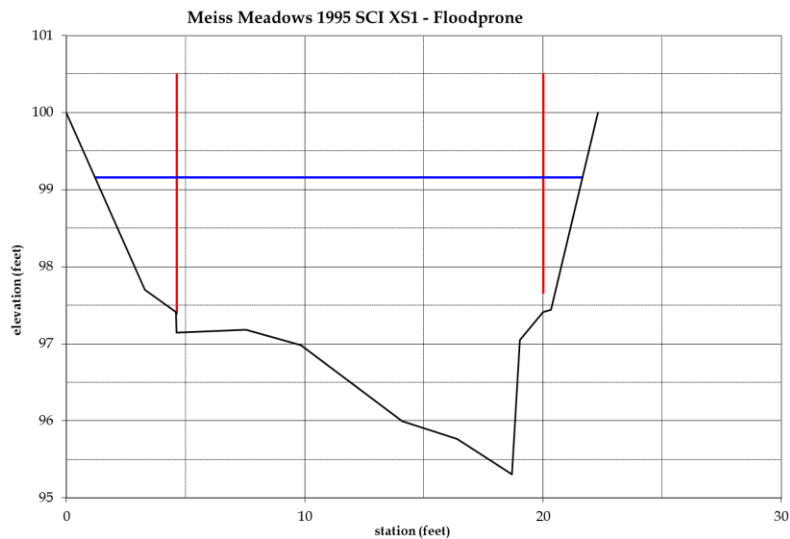
Cross Section 1 -1995

Meiss Meadows 1995 SCI XS1 hydraulic properties for floodprone water surface elevation:

w.s. elev	flow area	wetted P	hydr. radius	top width	hydr. depth	n value	darcy-weis. f	conveyance	discharge	velocity	shear
99.16	46.09	23.71	1.94	20.46	2.25	0.04	0.10	3291.68	197.50	4.29	0.44

Entrenchment ratio (FP width / BF width) = 1.3
